Technical Report HL-96-18
September 1996

Channel Stability Study, Flamingo Wash, Las Vegas, Nevada

by Ronald R. Copeland, Lisa C. Hubbard

Final report

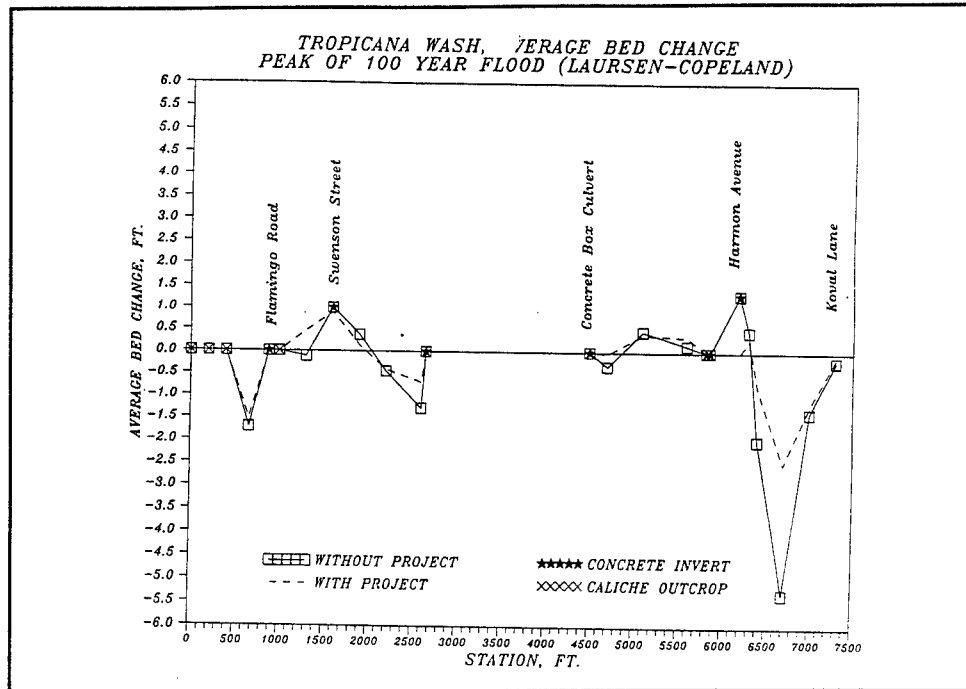
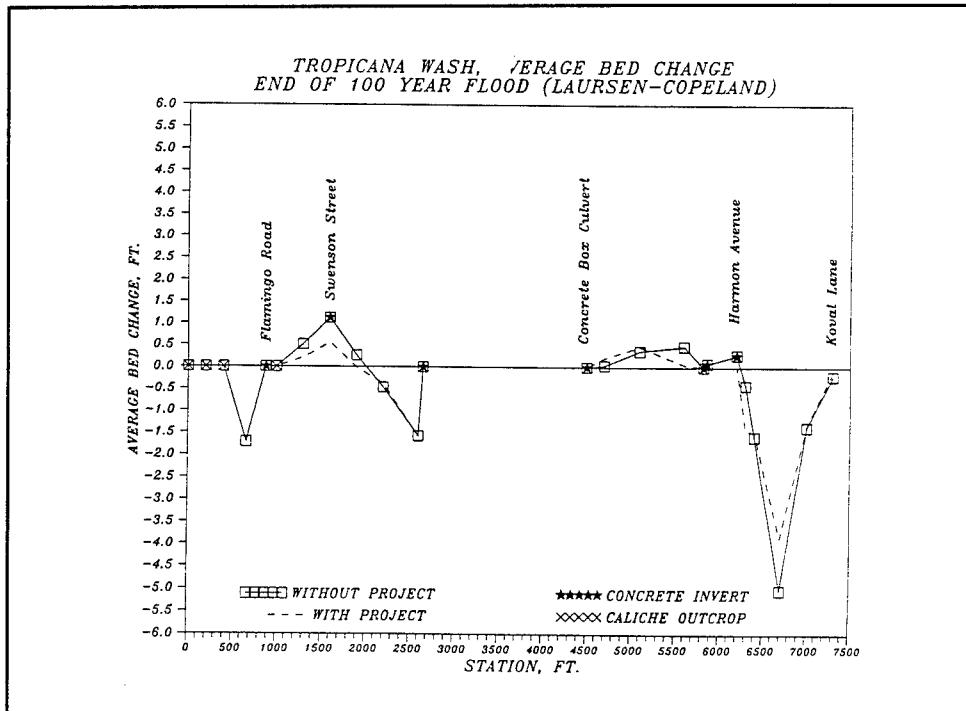
Figure 33. Calculated average bed changes, Tropicana Wash stations 0+00 to 73+00

Average bed elevation changes were calculated for the with-project one-percent-chance exceedance hydrograph and the without-project one-percent-chance exceedance hydrograph. Conditions at the peak of hydrograph are shown in Figures 33a-37a; and conditions at the end of the hydrograph are shown in Figures 33b-37b. Results are also tabulated in Tables 1 and 2. In most reaches, most of the calculated degradation occurred on the rising limb of the hydrograph, so that there was typically little additional degradation after the peak discharge. Typically, zones of degradation occurred downstream from culverts and concrete channel reaches. Aggradation frequently occurred downstream from degradation reaches or just upstream from culverts. In general, aggradation and degradation are significantly less severe for the with-project condition. It can be inferred that decreasing the aggradation and degradation potential will also decrease channel instability.

Outflow from the proposed dam will discharge into Tropicana Wash just downstream from Koval Lane. Due to upstream diversions, the total volume of water flowing through Tropicana Wash will increase with the project, even though the peak discharges will be less. This increase in flow volume has the potential for increasing degradation. In addition, the project will reduce sediment supply to Tropicana Wash, which could further increase the potential for degradation. This reach is therefore a relatively sensitive reach. Significant degradation was calculated on Tropicana Wash downstream from Koval Lane for both with- and without-project conditions and both at the peak and at the end of the flood hydrograph. Interestingly, calculated erosion was less for the with-project condition, even though sediment inflow into Tropicana Wash was eliminated by the project. At the peak of the flood hydrograph, deposition was calculated on Tropicana Wash at Harmon Avenue where the channel size is significantly reduced. Downstream from Harmon Avenue, through the grass-lined reach 2, channel bed elevation changes are relatively small on Tropicana Wash. Some degradation occurs in the channel as it exits the culvert downstream from Paradise Road, but the degradation is limited by caliche outcrops. Degradation potential is high on Tropicana Wash downstream from Flamingo Road, but caliche outcrops will tend to hold the

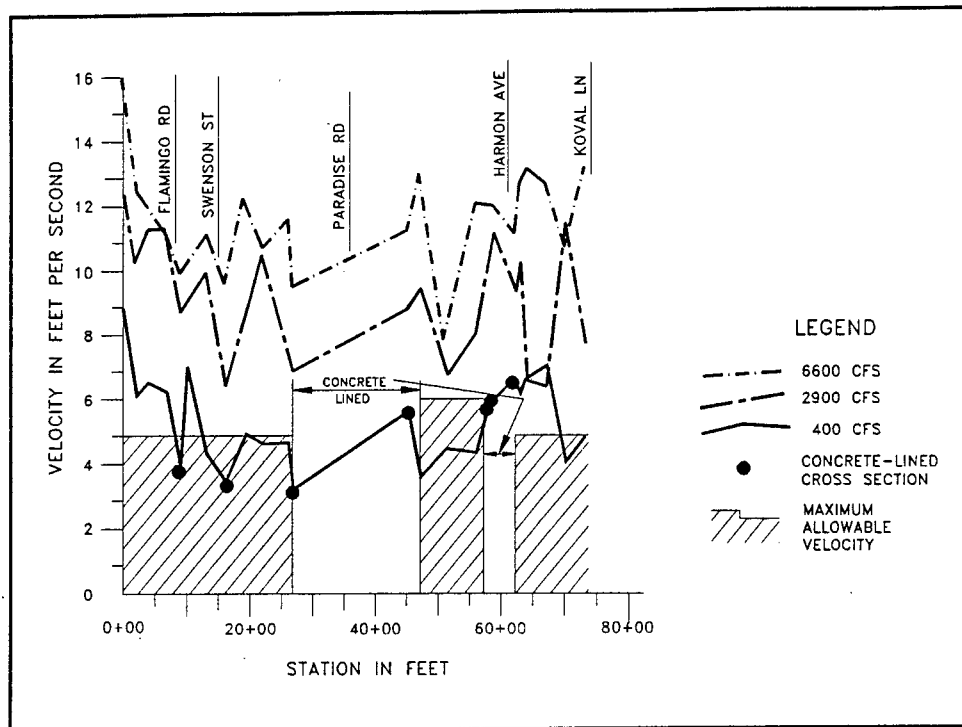
Figure 41. Maximum allowable velocities - Tropicana Wash, Station 0+00 to 73+00

Average channel velocities were calculated for the with-project one-percent-chance exceedance peak discharge of 6,600 cfs, the ten-percent-chance exceedance peak discharge of 2,900 cfs, and 400 cfs, which is the discharge that carries the most sediment during the with-project one-percent-chance exceedance hydrograph. Channel velocities were calculated using the initial channel geometry from the HEC-6W numerical model. These are compared in Figures 41-44 with allowable velocities of 6 ft/sec in grass-lined channels and 5 ft/sec in unlined channels. No consideration is given in this preliminary evaluation for existing rubble riprap or concrete-lined side slopes, because the bed is left unprotected. Caliche outcrops were not given consideration because the banks are left unprotected. Maximum permissible velocities would be less in reaches with significant channel curvature. Maximum permissible velocities would be greater if sufficient caliche deposit control can be confirmed.

The comparison confirms the conclusions reached in the channel inventory - that during major flood peak discharges, the existing channel is unstable in all reaches unless the channel is fully concrete-lined. At 400 cfs, the maximum allowable velocity is exceeded at about 40 percent of the cross sections. The grass-lined and fully concrete-lined reaches would be considered stable at this lower discharge. At a discharge of 400 cfs, the maximum allowable velocity is generally not exceeded in the unlined channel downstream from Boulder

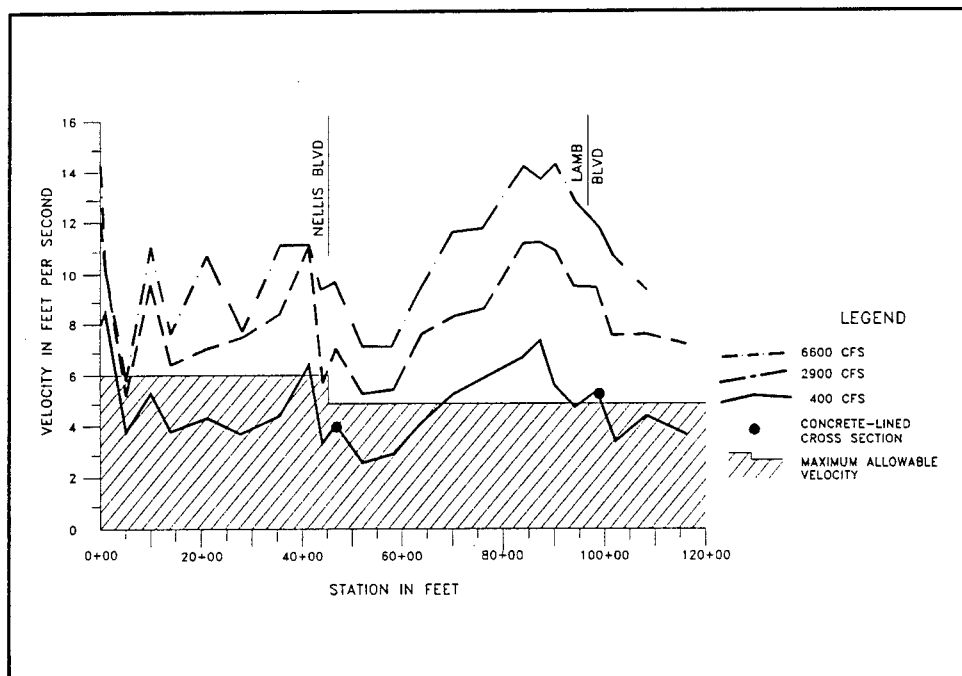
Figure 42. Maximum allowable velocities - Flamingo Wash, Station 0+00 to 116+00

Highway to Las Vegas Wash, except for the reach just downstream from Lamb Boulevard.

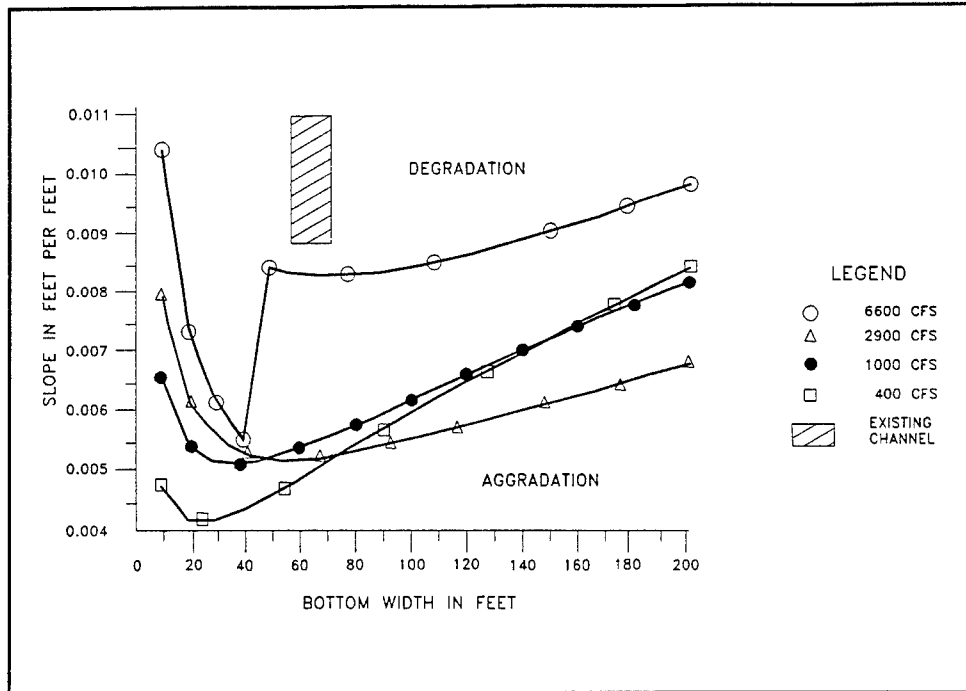
Figure 45. Channel stability curve - Flamingo Wash, Reach 13

The first reach downstream from reach 11 was a concrete-lined channel and required no analysis. The next reach, reach 13, between Mojave Road and Vegas Valley Drive, was a graded trapezoidal channel with a cut low-flow channel. The stable channel analytical method was applied to this reach to obtain a preliminary design estimate of stable channel dimensions. The proposed channel design was a trapezoidal channel that retained the unlined 1V:3H side slopes, which were assigned a roughness coefficient of 0.040. The stable channel calculations were made using the hydraulic design package SAM. The calculated stable channel design curves are shown in Figure 45. Also shown on this figure are the base width and slope ranges of the existing channel. The existing channel dimensions plot well above the stability curves for all discharges, indicating an existing channel regime subject to degradation. Since the existing channel passes through a residential neighborhood, it would be difficult to widen the channel. Therefore, retaining the existing channel base width of about 60 ft, a design channel slope of 0.0050 is obtained from the stability curves for 2,900 cfs. The estimated design slope is about 50 percent of the existing channel slope. An 11-ft drop would be required through the 2000-ft-long reach to attain this slope. Calculated water depth at 2,900 cfs is 5.8 ft, average channel velocity is 6.4 ft/sec, and the composite roughness coefficient is 0.046. This high roughness coefficient is the result of bed-form roughness calculated by the Brownlie equations. The discontinuity in the stability curve for 6600 cfs is due to transition from upper regime plane bedforms to lower regime dune bedforms.

The stable channel method only provides for sediment transport capacity through the reaches. In all the reaches studied herein, the calculated channel velocity was higher than the maximum permissible velocities. Therefore, bank protection would be required for all these stable channel designs.

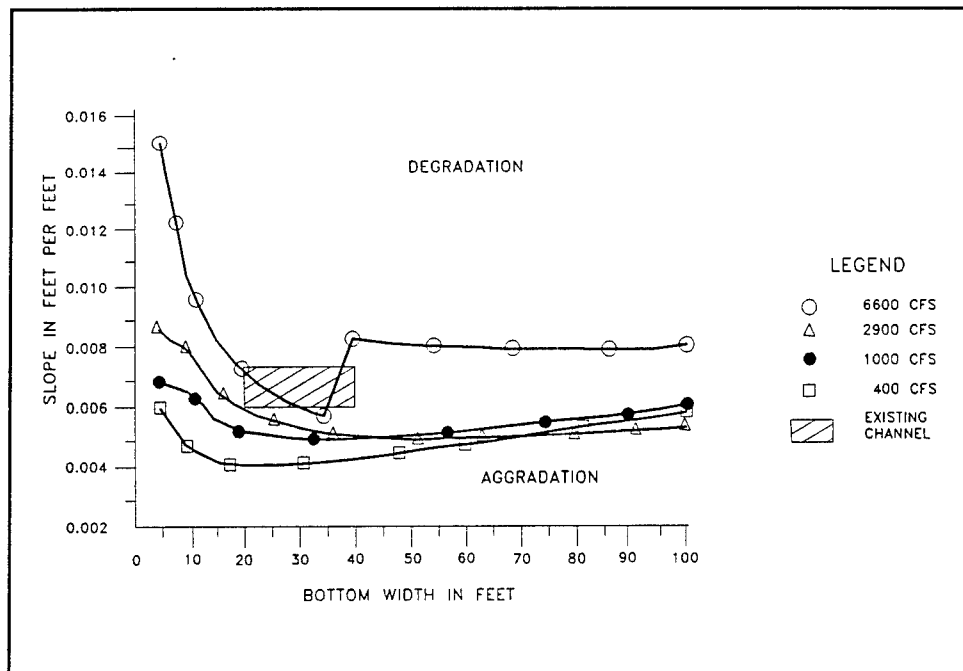
Figure 46. Channel stability curve - Flamingo Wash, Reach 14

The stable channel method was applied to the next reach downstream, reach 14, located between Vegas Valley Drive and Boulder Highway. The existing channel in this reach is generally trapezoidal in shape with irregular 1V:2H bank slopes. The design channel was assumed to retain the same shape as the existing channel. The banks were assigned a roughness coefficient of 0.050. For design purposes, sediment inflow was assumed to come from reach 11. The calculated stability curves are shown in Figure 46. Also shown are the ranges of slope and base width in the existing channel. The existing channel dimensions fall above the stability curves for all discharges except the one-percent-chance exceedance peak. This indicates that the channel would be relatively stable during the peak of the one-percent-chance exceedance hydrograph but would be subject to degradation at the other discharges. Using an average channel base width of 30 ft, which matches the existing channel, a design slope of 0.0053 is suggested for 2,900 cfs. This is only a 15 percent decrease from the existing channel slope. A 1.5-ft drop would be required in this 1600-ft-long reach to attain this slope. Calculated water depth at 2,900 cfs is 8.7 ft, average channel velocity is 7.0 ft/sec, and the composite roughness coefficient is 0.051. This high roughness coefficient is the result of bed-form roughness calculated by the Brownlie equations.

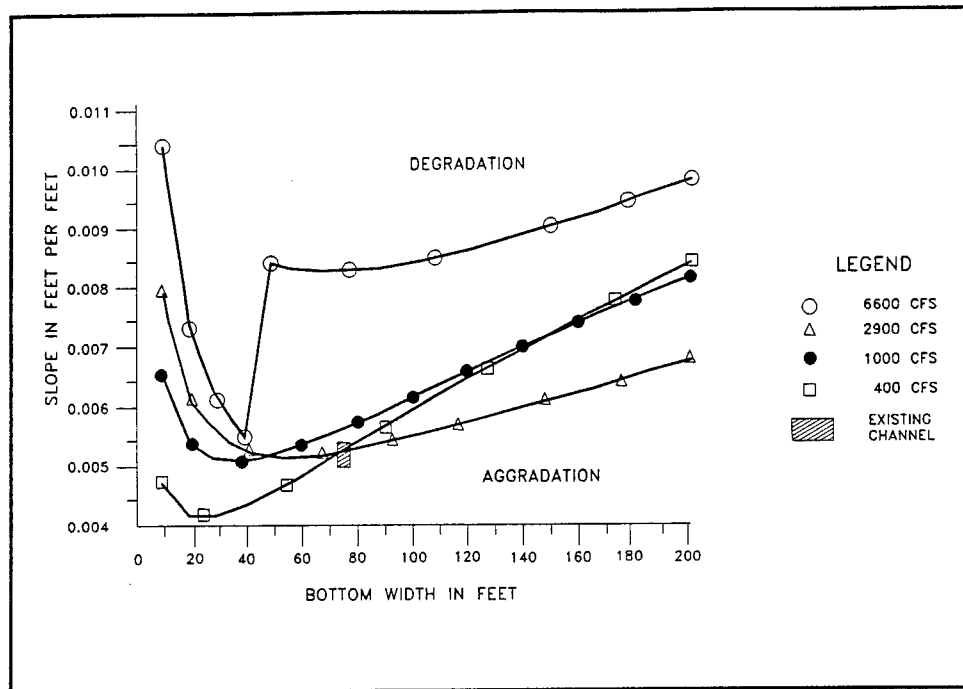
Figure 47. Channel stability curve - Flamingo Wash, Reach 16

Between Interstate-515 and Lamb Boulevard is reach 16, an unlined trapezoidal channel with 1V:3H side slopes. The same channel shape was assumed for the stable channel design. A bank roughness coefficient of 0.040 was assigned. Reach 16 has the same stability curves as reach 13 because the channel side slopes are the same and the sediment supply reach is the same. The stability curves are shown in Figure 47 with the existing channel ranges of slope and base width. The stability curves indicate that the existing channel should be stable for all discharges, except the one-percent-chance exceedance discharge. At a discharge 6,600 cfs, aggradation is predicted. The analysis suggests that the existing slope of about 0.0052 and base width of 75 ft be retained. For a discharge of 2,900 cfs, calculated water depth is 5.2 ft, average channel velocity is 6.1 fps, and the composite roughness coefficient is 0.047.

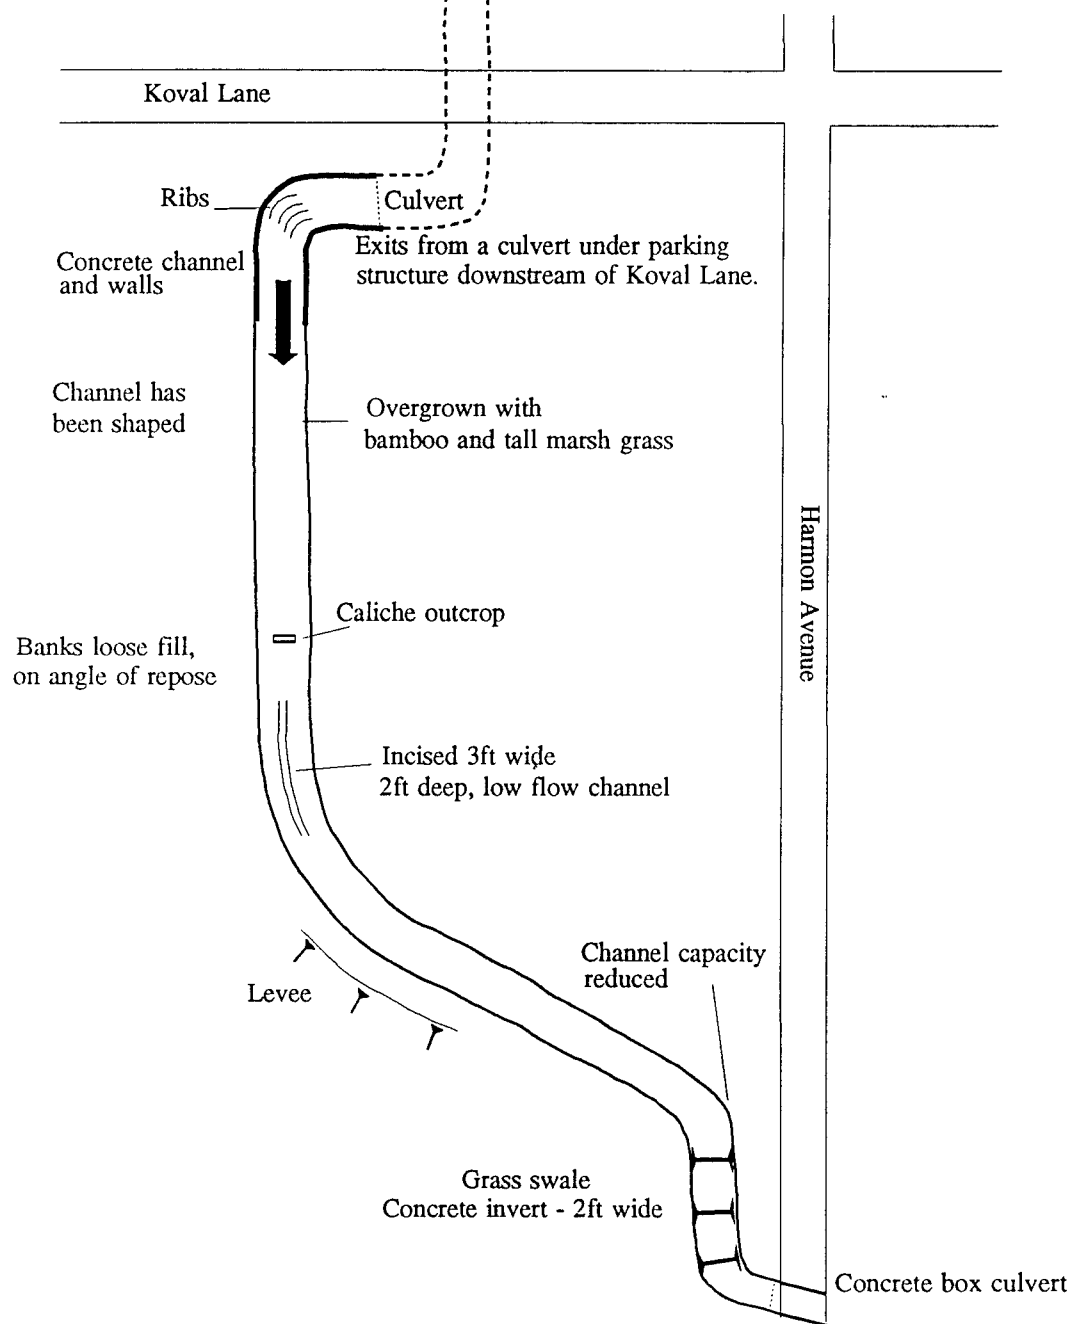
REACH 1
KOVAL LANE TO HARMON LANE

bamboo. Further downstream, over the next 200 ft, the channel was vegetated with shrubs and bushes, and the banks consisted of loose fill. There appeared to be a caliche outcrop in the bed about 250 ft downstream from the concrete-lined channel. At the mid-point between Koval Lane and Harmon Avenue, where the channel curved to the left, there appeared to be a short levee on the right bank protected by concrete rubble. An incised low-flow channel that was about 3 ft wide and 2 ft deep was observed at this location. As the channel approached Harmon Avenue, its capacity decreased significantly. The reduced capacity channel made a tight right turn and paralleled Harmon Avenue for about 200 ft. Adjacent to Harmon Avenue the channel was a grassed swale with a 2-ft-wide concrete invert. Due to the limited capacity of the grassed swale and the tight bend upstream it is expected that flood flows would leave the channel and flow eastward down Harmon Avenue. It is also expected that some of the flood breakout would be captured again on the downstream side of Harmon Avenue. A six-bay concrete-box culvert passed under Harmon Avenue. It had a total height of 8.3 ft, and in August 1994 about 1 ft of mud had deposited on the culvert invert. Plate 3 is a plan view sketch of the reach.

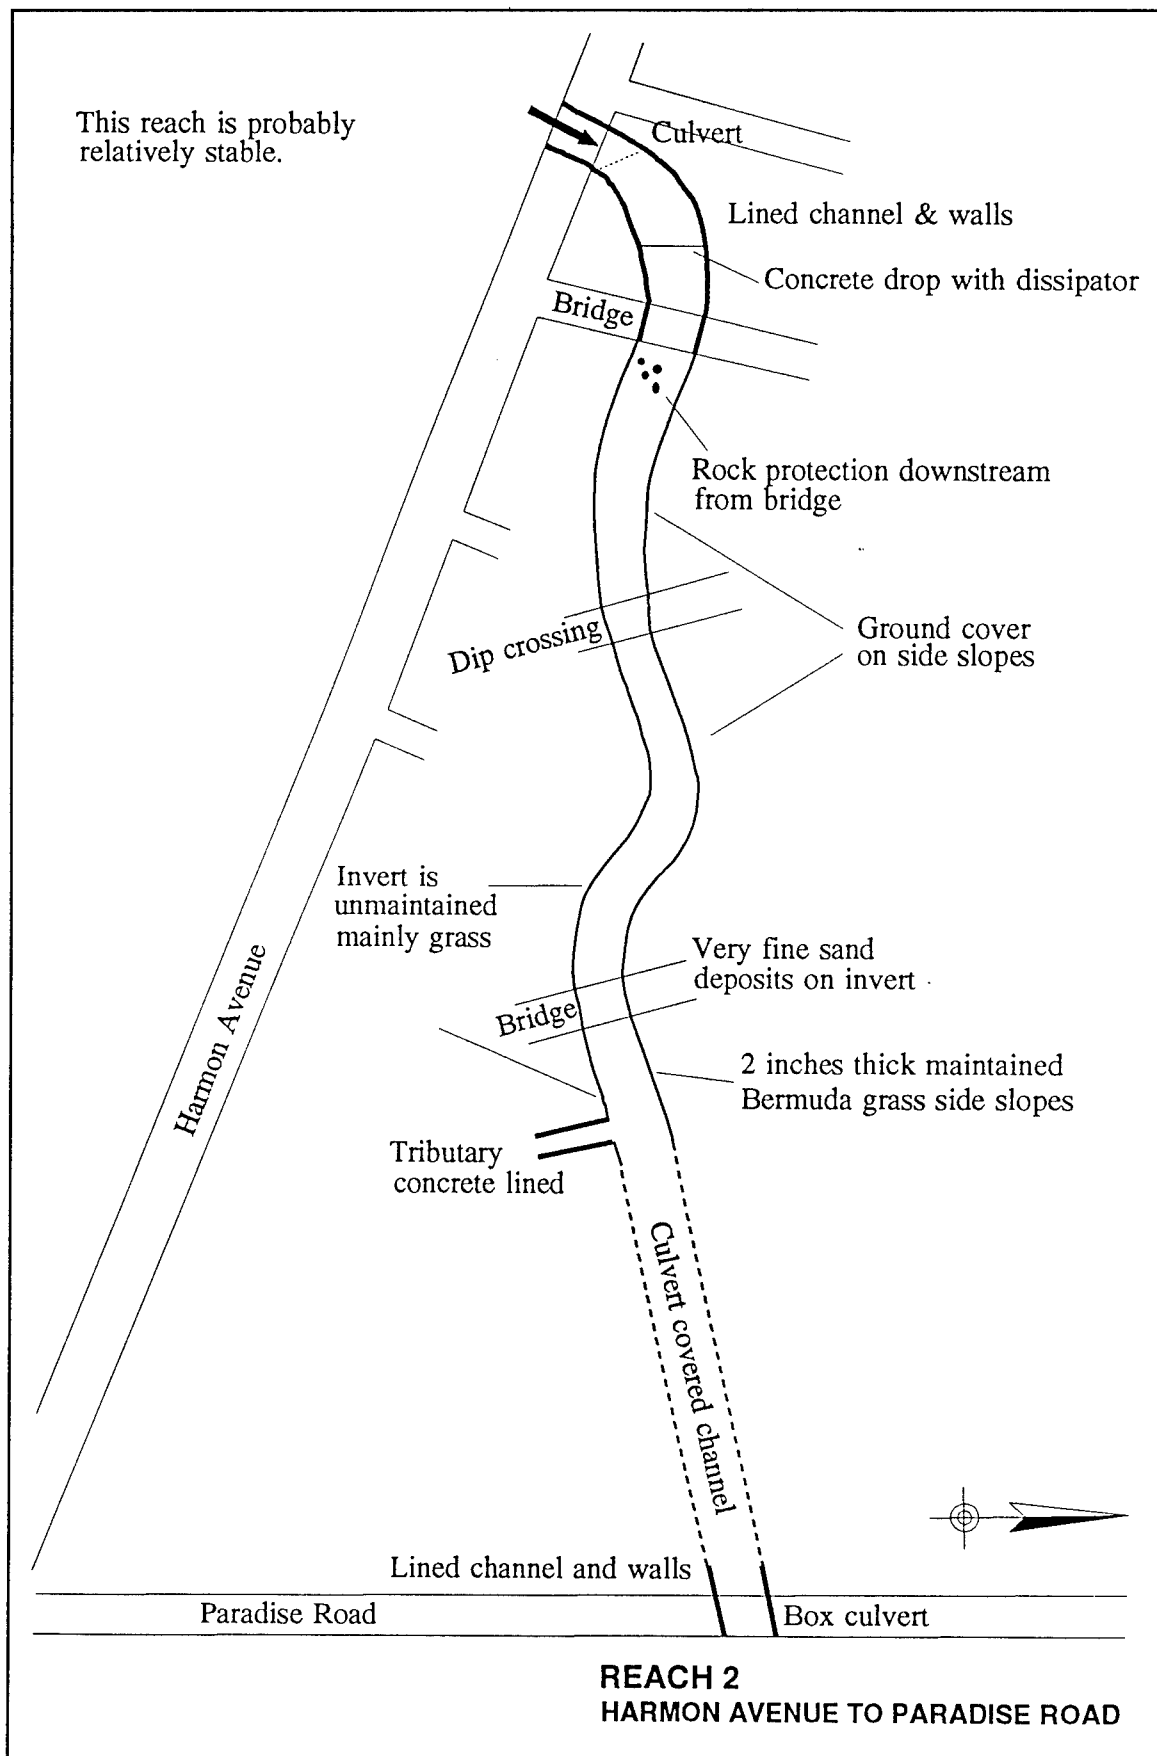
Plate 4

Downstream from Harmon Avenue, for about 150 ft, the channel was concrete-lined. At the end of the concrete-lined channel there was a 3- to 4-ft drop structure and an energy dissipator (Figure 2). Downstream from the dissipator the channel was grass-lined. Low vegetative ground cover was maintained on the side slopes between a driveway bridge, located about 250 ft downstream from Harmon Avenue, and a point 900 ft downstream from Harmon Avenue (Figure 3). Downstream from that point, both the invert and side slopes were grass-lined. Most of the grass in the channel was well maintained in August 1994, but there were a few spots where it had died and bare ground was exposed. Underneath the driveway bridge there were large cobbles and boulders that looked like they had been positioned to hold the low-flow channel. A paved dip road crossing was located about 600 ft downstream from Harmon Avenue. The grass-lined channel runs into a concrete multi-bay culvert which is located 1400 ft downstream from Harmon Avenue. The features described for reach 2 are shown in Plate 4.

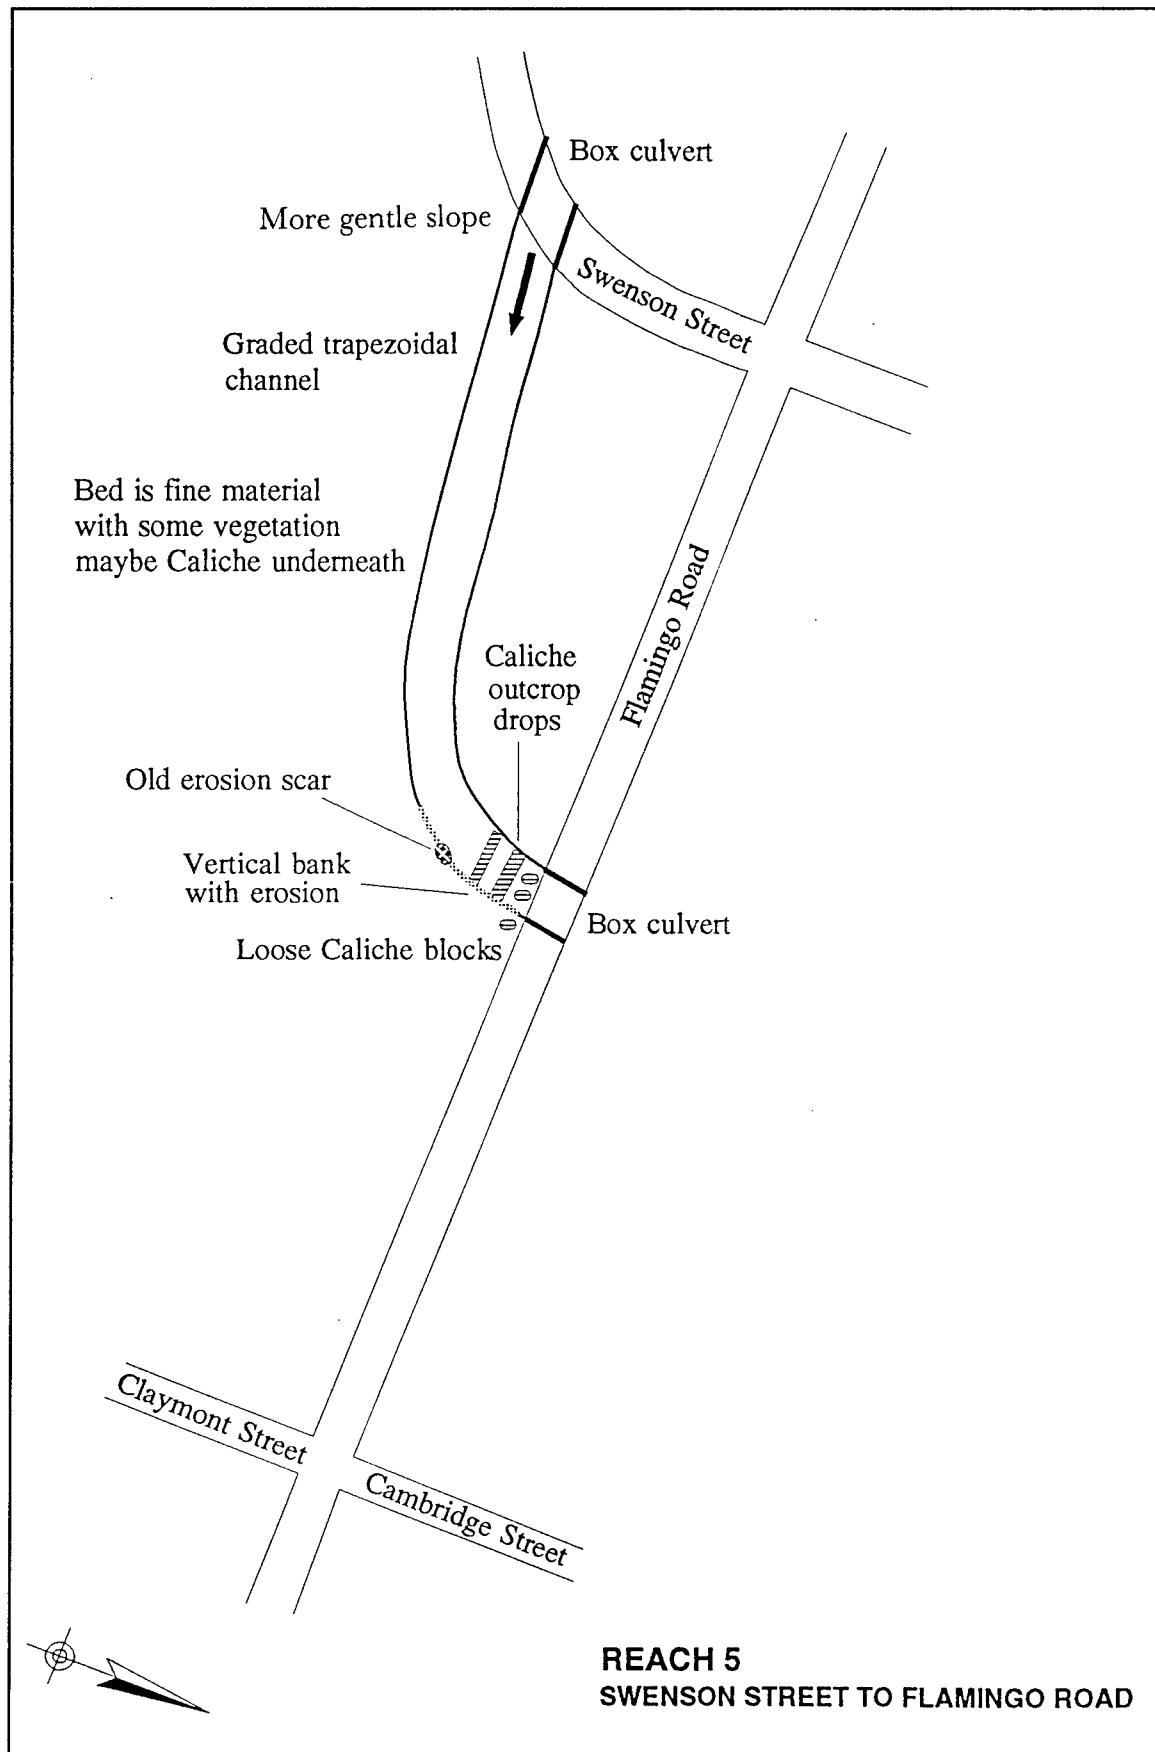
Layered deposits were observed in a three-ft-high vertical cut just upstream from Flamingo Road. As shown in Figures 5 and 6, the lower layer, which was composed of sand and pebbles, was being undercut and had a small detritus deposit at the toe. The sand and pebble layer was covered by a series of layers composed of finer material, another sand and pebble layer, and then additional layers of finer material. This suggests that bank erosion potential along the channel may vary considerably depending on the characteristics of the alluvial deposits that make up the bank at specific locations. These characteristics are typically hidden by channel grading projects and are visible only when erosion exposes the actual bank composition. Considering that the banks in this reach were observed to have layers composed of non-cohesive sand and pebbles, bank erosion potential should be considered high. Materials composing these layers are more easily removed by flowing water and are more subject to blowout by positive pore pressure in the bank than cohesive materials.

There was a major caliche drop located about 50 ft upstream from Flamingo Road. The total vertical drop was about four feet (Figure 7). The caliche drop demonstrated both the potential for degradation in this reach and the ability of the caliche deposits to form a bed control. Broken caliche fragments were observed downstream from the drop which demonstrated that the deposit was subject to failure and could not be considered a permanent hydraulic control structure. Upstream from this large drop, the caliche outcrops were not visible across the full channel width.

At Flamingo Road the channel entered a triple concrete-box culvert. Sloping pier noses should decrease the potential for floating debris build-up at the culvert entrance. Sediment deposits were observed in the culvert during the August 1994 field reconnaissance. About 6 to 12 inches of broken caliche and mud had deposited in the left bay. At the culvert exit, downstream from Flamingo Road, the natural channel bed was about 1 ft lower than the concrete invert. Plate 6 is a plan view sketch of the features in this reach.

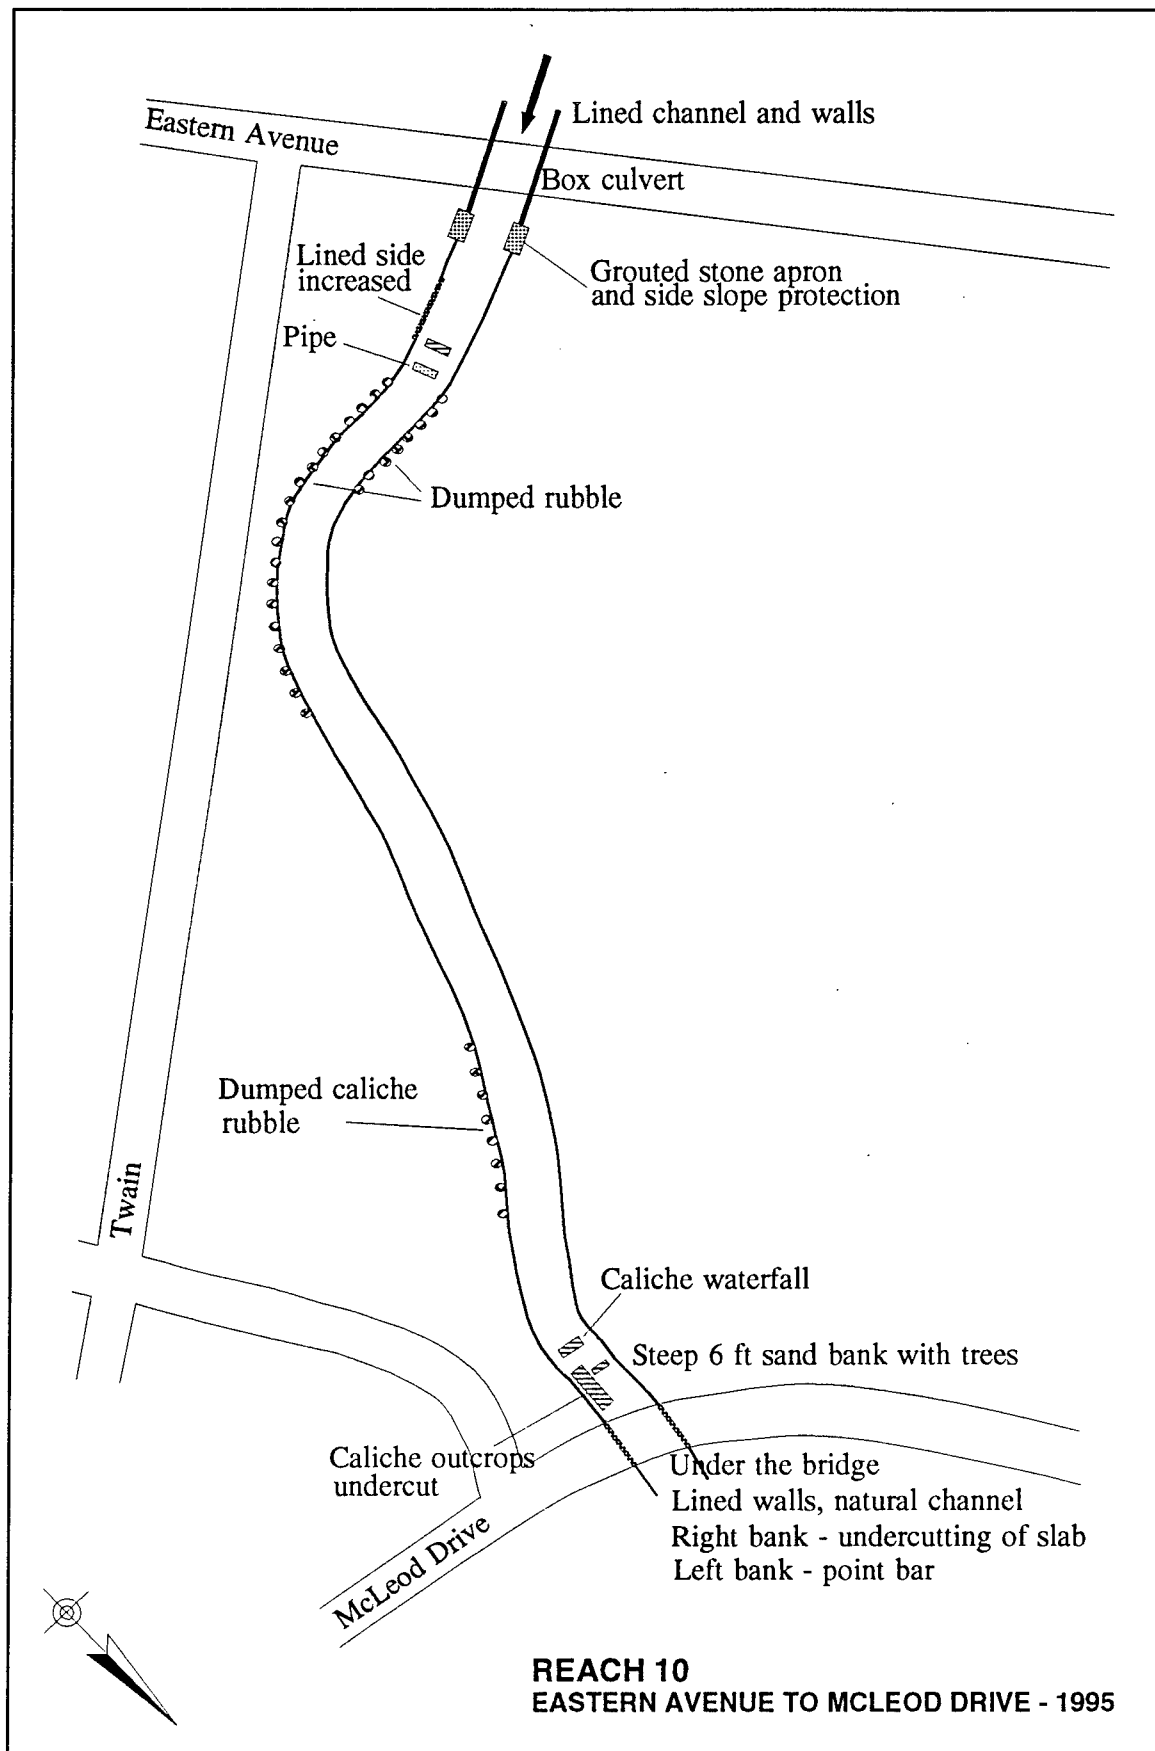
Plate 10

The bridge under McLeod Drive had concrete-lined side slopes and a natural invert. There was a gravel bar on the left bank, and undercutting of the slab on the right abutment was observed in August 1994. Evidence that repair work had occurred on the right abutment was observed. A plan view sketch of this reach is shown in Plate 10.

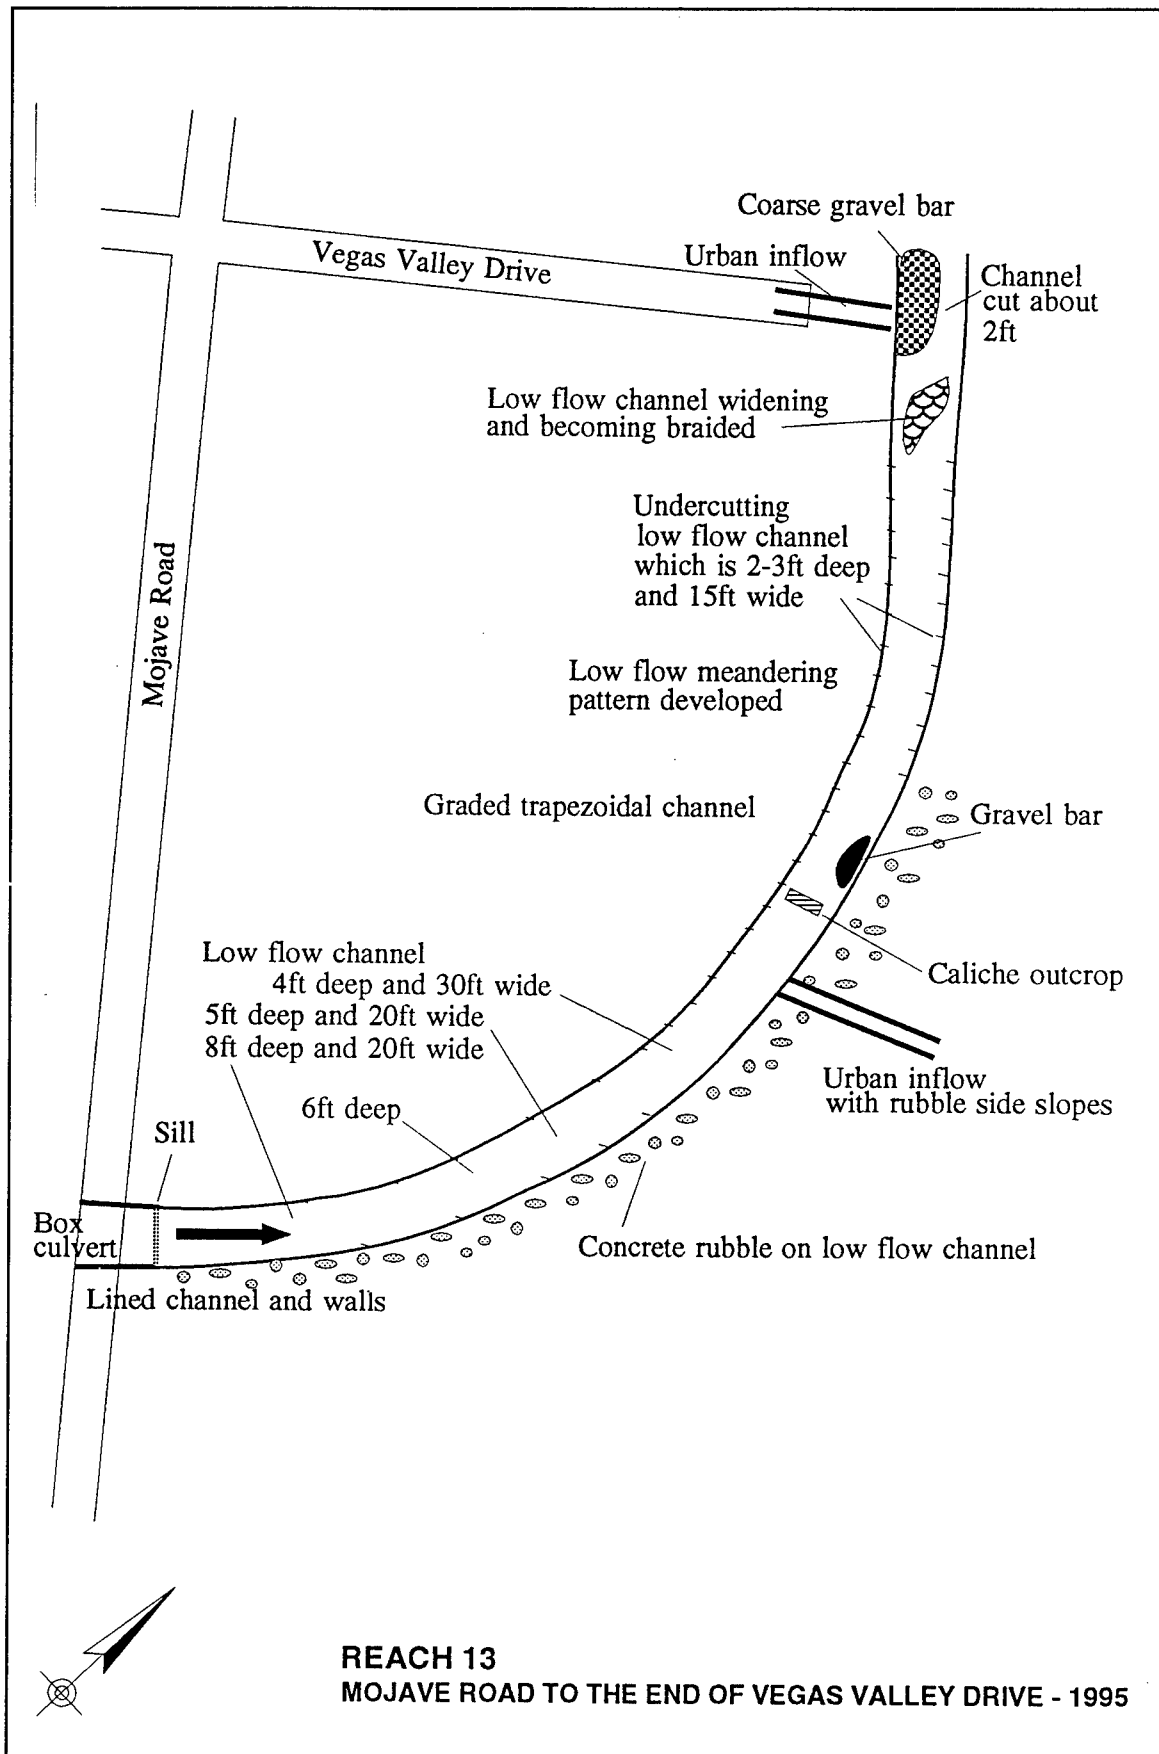
Downstream, towards Vegas Valley Drive, the low-flow channel widened and became shallower. The bed seemed to consist of a gravel mobile armor layer, and the bank material was unconsolidated. The notes in Plate 12 point out the variability of the low flow channel in this reach.

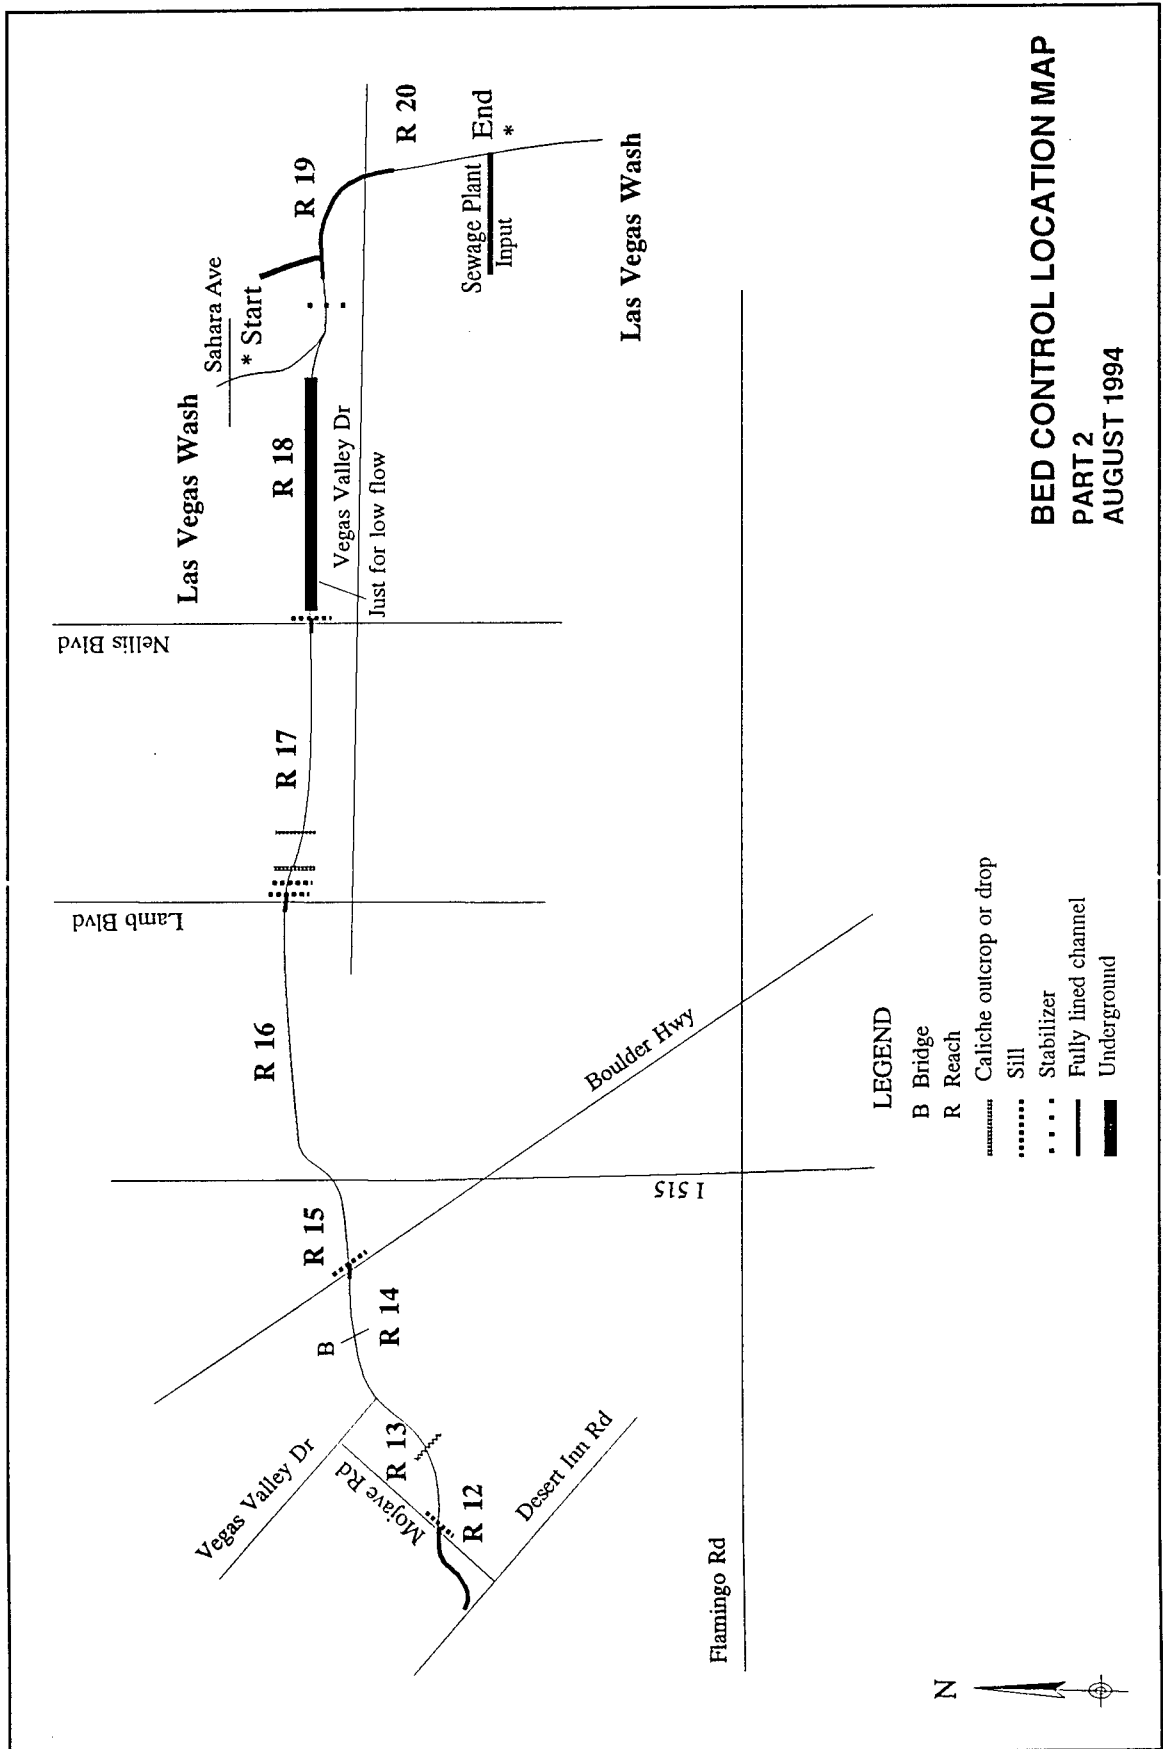
Plate 14

Degradation in Flamingo and Tropicana Washes is checked by numerous bed controls present in the system. The locations of both man-made and natural bed controls are shown in Plates 14 and 15.
